MODELLING FROM THE PAST: THE LEANING SOUTHWEST TOWER OF CAERPHILLY CASTLE 1539-2015

O. E. C. Prizeman^{a,*}, V. Sarhosis^b, A. M. D'Alri^c, C. J. Whitman^a, G. Muratore^d

KEY WORDS: Masonry, Tower, Point Cloud, Numerical Modelling, Terrestrial Laser Scanning

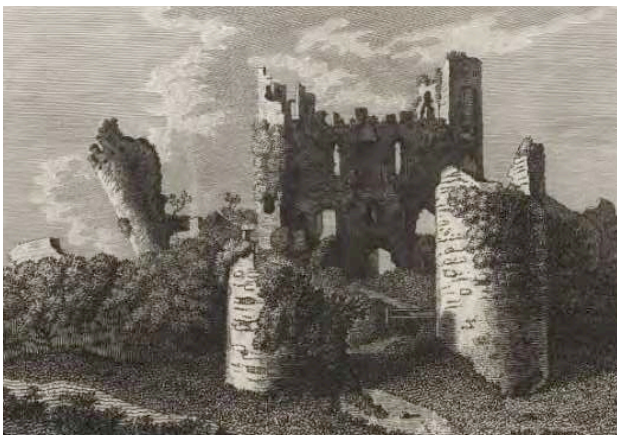
Figure 2. Caerphilly or Sengenneth Castle Pl2 P.Sandby Godfrey 1773 (Grose, 1783)

In 1774 Richard Godfrey, b.1728 and Sparrow depicted Caerphilly [sic] or Sengeneth castle in ruinous state – see figure 2. Grose quoted Leland who described in 1539: "Mr. Wood, of Bath, who lay on his back, for several minutes to view this dreadful ruin, its lineal projection, on the outer side, is not less than ten feet and a half". (Grose, 1783). In 1830 the tower is depicted as leaning eleven rather than ten feet: "This bulky fragment of the ruin is between seventy and eighty feet in height, and of a prodigious thickness. It hangs nearly eleven feet out of the perpendicular" (Gastineau et al., 1830). Using the measurements taken from the laser scanner today, it is evident that the greatest lean extends a little over 9ft (2.85m).

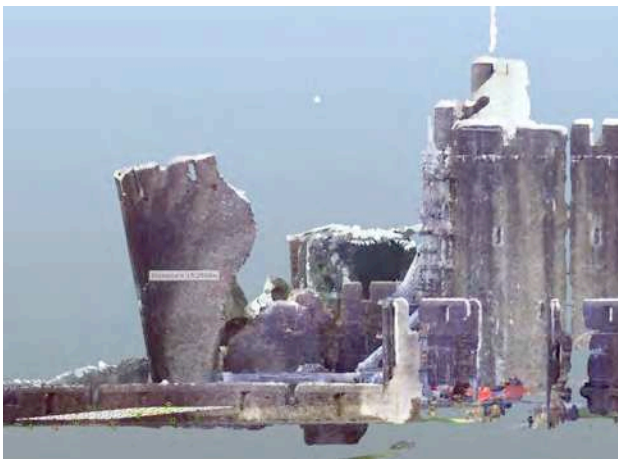
Figure 3. Elevation form laser scan

The laser scan of the south west tower was undertaken by architects during a commission to document the south east tower "tumbles". Using a FARO focus 3D X130 terrestrial laser scanner, a total of 27 scans were made. The inclinometer, altimeter, compass, clear contour and clear sky were also activated and far distance deactivated. The scans were made at a resolution of 1/5 of 28.2 Mpts with 4x quality. The point distance was 7.67mm/10m. A series of scans were taken from points on the ground around the base of the tower, there were challenges in gaining clear lines of sight posed by scaffolded areas and the presence of tourists. A publically accessible first floor walkway through the rear of the tower enabled scans to be
